City of Tigard

ADDENDUM #1

DERRY DELL CREEK AT 118TH COURT STREAMBANK STABILIZATION AND OUTFALL REPAIR ENGINEERING, STREAM RESTORATION, AND CONSTRUCTION MANAGEMENT SERVICES

**RE: SUMMARY LETTER REPORT
13800 SW 118TH COURT LANDSLIDE EMERGENCY RESPONSE
AND DERRY DELL CREEK HAZARD RECONNAISSANCE
TIGARD, OREGON**

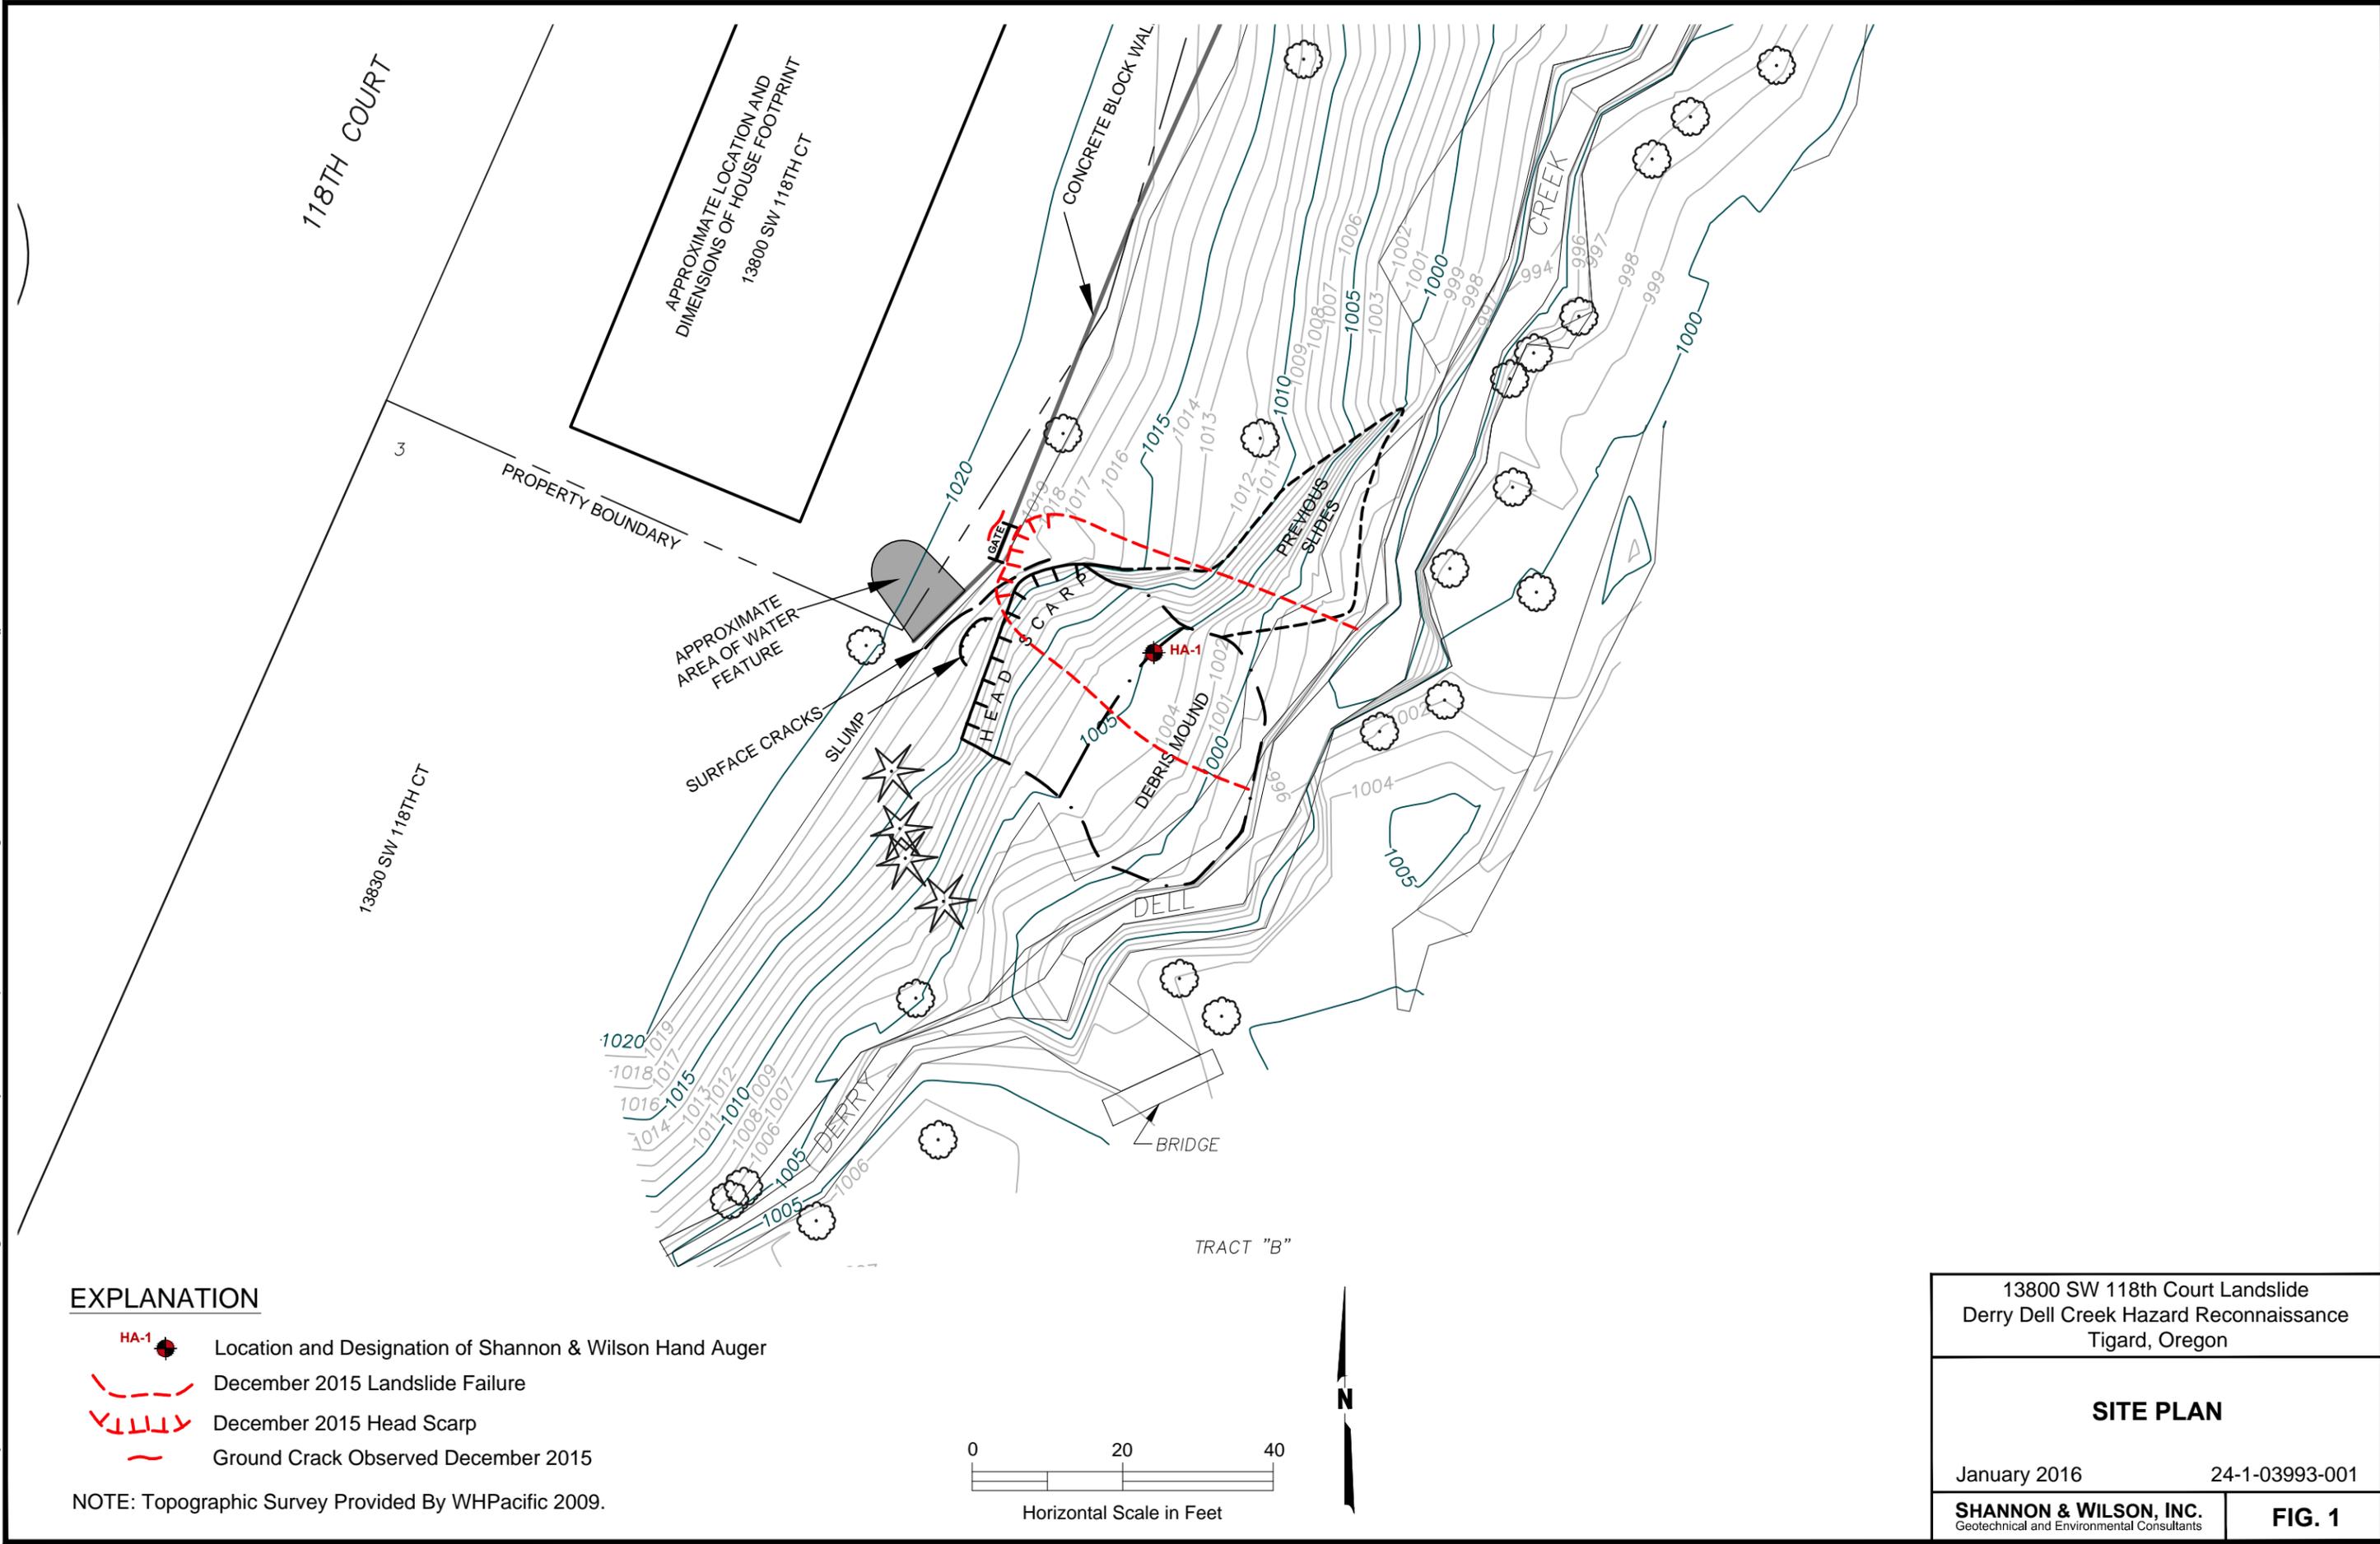
13800 SW 118th Court Landslide Derry Dell Creek Hazard Reconnaissance Tigard, Oregon	
SITE PLAN	
January 2016	24-1-03993-001
SHANNON & WILSON, INC. Geotechnical and Environmental Consultants	FIG. 1

During our February 12, 2009, reconnaissance we observed that the landslide had occurred just behind the concrete block privacy wall near the southeast property corner as shown in Figure 1. The head scarp was located several feet below the gate at 13800 SW 118th Court and extended to the south below the neighboring property at 13830 SW 118th Court. At the nearest point, the head scarp was about 4 feet from the south gate post and 9 feet from the property boundary at 13800 SW 118th Court. The head scarp was approximately 12 feet from the property boundary at 13830 SW 118th Court at the nearest point. A series of ground cracks and slumps were observed in soil behind the head scarp, which extended the active slide area to about 2 feet away from the wall. The slide was approximately 20 feet wide at the head scarp and about 40 feet wide at the toe. The slide was approximately 45 feet in length from the top of the head scarp to the toe of the slide debris near the creek channel. The slide appeared to have been a debris slump forming a prominent bench in the mid-portion of the slide area, about 5 to 7 feet below the rim of the head scarp. The bench was the upper surface of a debris mound that, having failed from its original position, settled at the edge of the creek.

During our recent December 30, 2015, reconnaissance we observed that the northern half of the landslide had recently failed as a debris flow landslide, increasing the overall size of the landslide to approximately 35 feet wide at the head scarp and about 50 feet wide at the toe as shown in Figure 1. The northern portion of the head scarp has retrogressed upslope and is now 1 foot away from the gate and wall. In the recent failure area in the north half of the landslide, the head scarp has retrogressed upslope and the prominent bench debris mound that had been 5 to 7 feet below the rim of the head scarp (as described in our February 12, 2009 reconnaissance) has slid away as a debris flow landslide, forming a debris field that extends into the creek channel. It appears that much of the soil debris has been washed down stream. The remaining landslide debris extends from the head scarp to the creek channel and appears to mound immediately adjacent to the creek. The neighbor located at 13830 SW 118th Court told us that the recent debris flow occurred a couple weeks prior to our December 30, 2015, reconnaissance.

During our December 30, 2015, reconnaissance we observed that the recent debris flow landslide is 10 to 20 feet wide, occupying the northern half of the overall landslide. The head scarp of the recent debris flow as shown in Figure 1 is near vertical, 12 to 13 feet high, 10 to 12 feet wide, and is within 1 foot of the gate. We also observed that there are now ground cracks on

Based on our surface observations, there is a risk that additional landslide failures in the northern half of the landslide at 13800 SW 118th Court could occur at any time and encroach into the backyard of the residence at 13800 SW 118th Court. The condition and extents of the southern half of the landslide below the neighboring property at 13830 SW 118th Court appears similar to what we observed in 2009. This portion of the landslide appears less active and it is set back further from the property line; therefore, there is a lower risk that the landslide will encroach into the property at 13830 SW 118th Court. The December 2015 debris flow landslide at 13800 SW 118th Court was caused by excess water from surface and near surface drainage originating from record-setting December rainfall. Surface grading and the block wall in the backyard of the residence at 13800 SW 118th Court funnel rainwater surface runoff toward the gate, which is located above the center of the December 2015 landslide area.

In our opinion, the drainage improvements discussed above should be implemented immediately to the landslide below 13800 SW 118th Court. During the remainder of the wet season, the condition of the landslide should be monitored by the City on a weekly basis. If permanent stabilization consisting of a retaining wall or rock buttress is to be constructed this summer, the additional temporary stabilization measures discussed above may not be warranted due to the 6-foot setback of the property line from the current head scarp and a slight reduction of risk due to implementation of drainage improvements. The next landslide failure may not reach the property line and it may be possible to rapidly implement temporary stabilization prior to a successive failure extending beyond the property boundary. However, we cannot assure that the next landslide failure will not extend beyond the property line or that temporary stabilization can be installed in time to prevent additional damage. If permanent stabilization consisting of a retaining wall or rock buttress is not to be constructed this summer, we recommend installing temporary stabilization measures consisting of plate piles as soon as permissions can be obtained
